Manhole Inspection Summary

Manhole # S25Q__017MH

Insp Date: **4/8/08 2:13 PM**

Location Address: **1411 BUSH ST.**

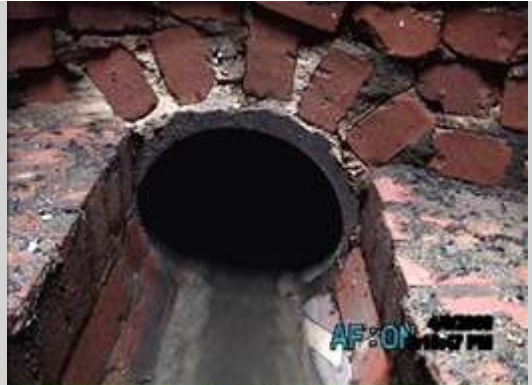
12 O'Clock Outflow

10 in. Circular Gravity Sewer
Pipe Out @ 12 O'Clock

Pipe Height: **10.8** (in.) Rod and Bar (Angled)
Pipe Material: **Clay** ☐ Pipe Lined
Invert Depth: **7.80** (ft.) Flow Characteristics: **Slow**
Deposits: ☒ None ☐ Mud ☐ Sludge ☐ Debris ☐ Grease
Silt Depth: **0** (in.) Deposits Extent:
Infiltration: **None** Pipe Seal Cond: **Sound**

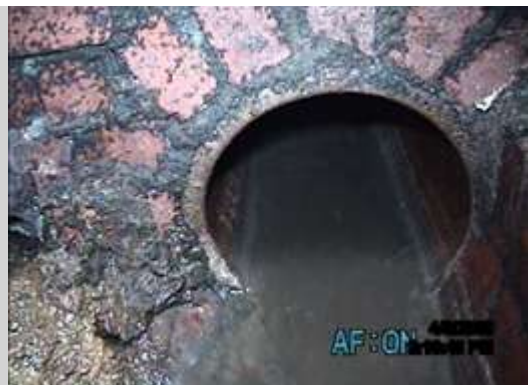
6 O'Clock Inflow

10 in. Circular Gravity Sewer
Pipe In @ 6 O'Clock

Pipe Height: **10.8** (in.) Rod and Bar (Angled)

Infiltration: **None** Pipe Seal Cond: **Sound**
